STIDD Systems, Inc.

Technical Bulletin - No. 80523

Model: 500N-V5 Helm Seat

Weld inspection suggested on all 500N-V5 Helm Seat pedestals (p/n: 510-1100-V5-F) installed on USCG 47' Motor Life Boats.

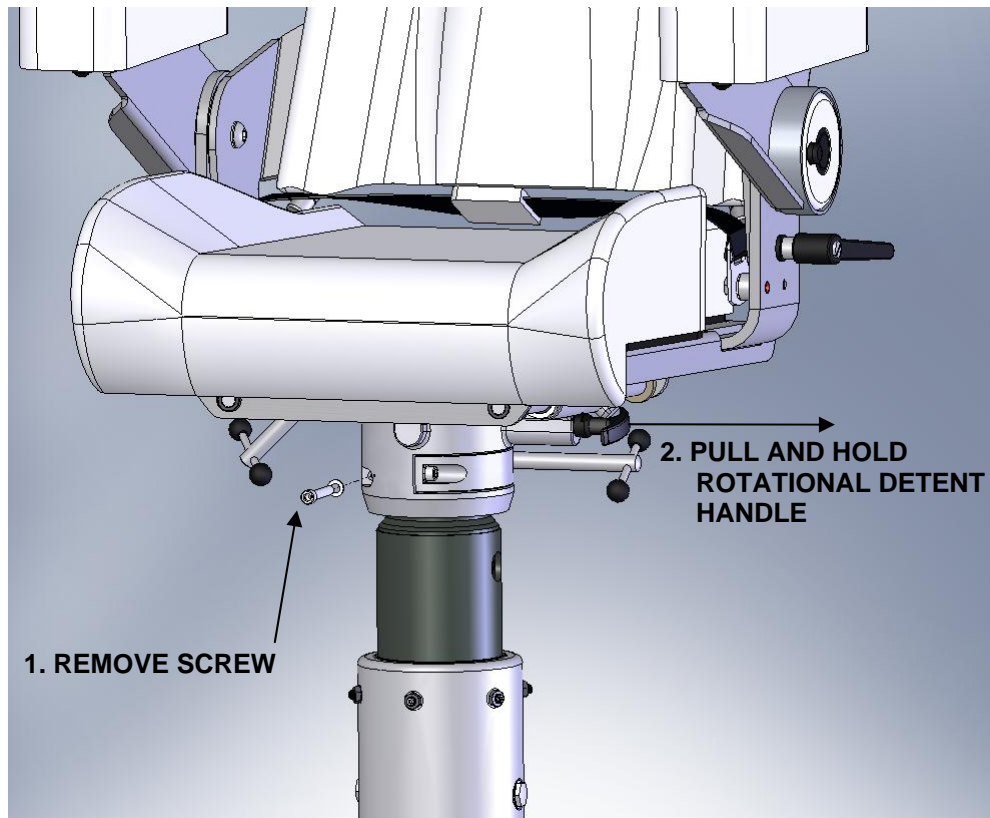
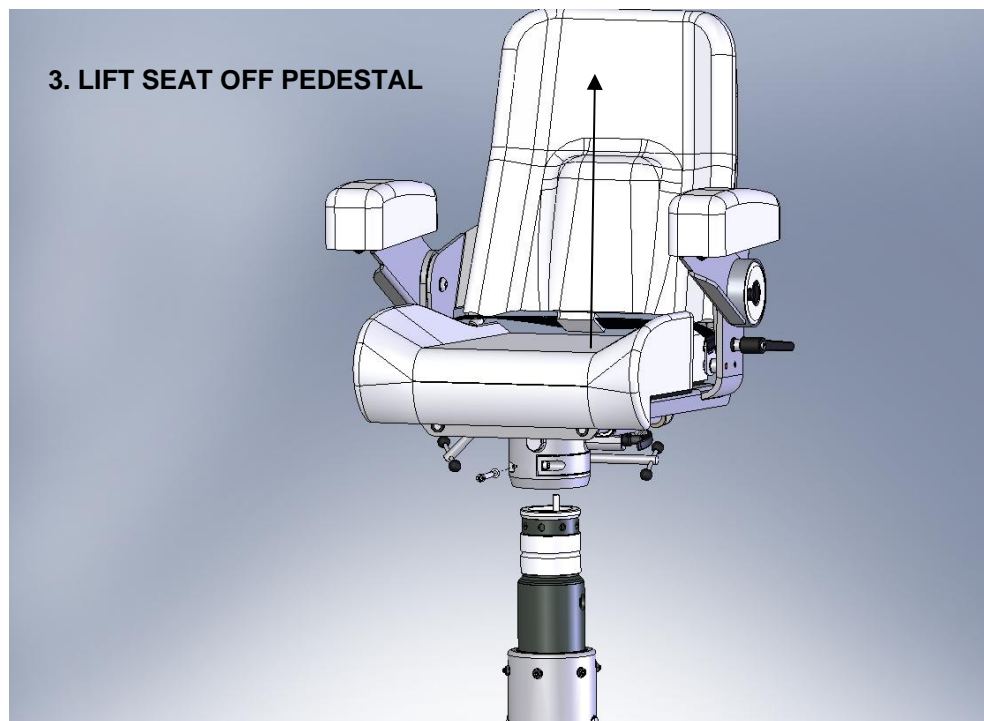
FIGURE 1 – SEAT REMOVAL

- 1) Remove the seat from the pedestal. (See Figure 1)
- 2) Using a soap and water solution, clean the top of the pedestal inner post as well as the weld zone in question. (See Figure 2)
- 3) Visually inspect the weld zone for any signs of cracking. (See Figure 3)
- 4) Place the STIDD supplied weld gauge on the top of the pedestal as shown in Figure 4.
- 5) Inspect the weld in several locations around the diameter of the inner post. See Figure 5 for the pass/fail criteria. The weld inspection is categorized as a failure if at any point around the pedestal the weld is not within the pass/fail window.

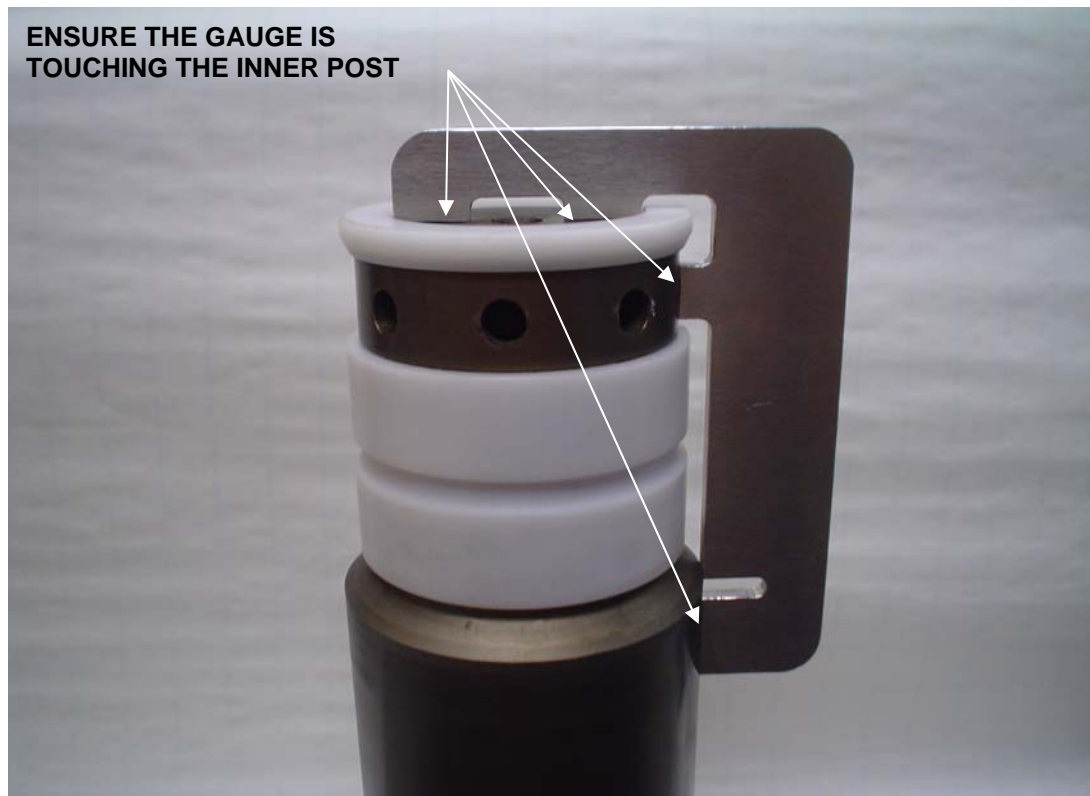
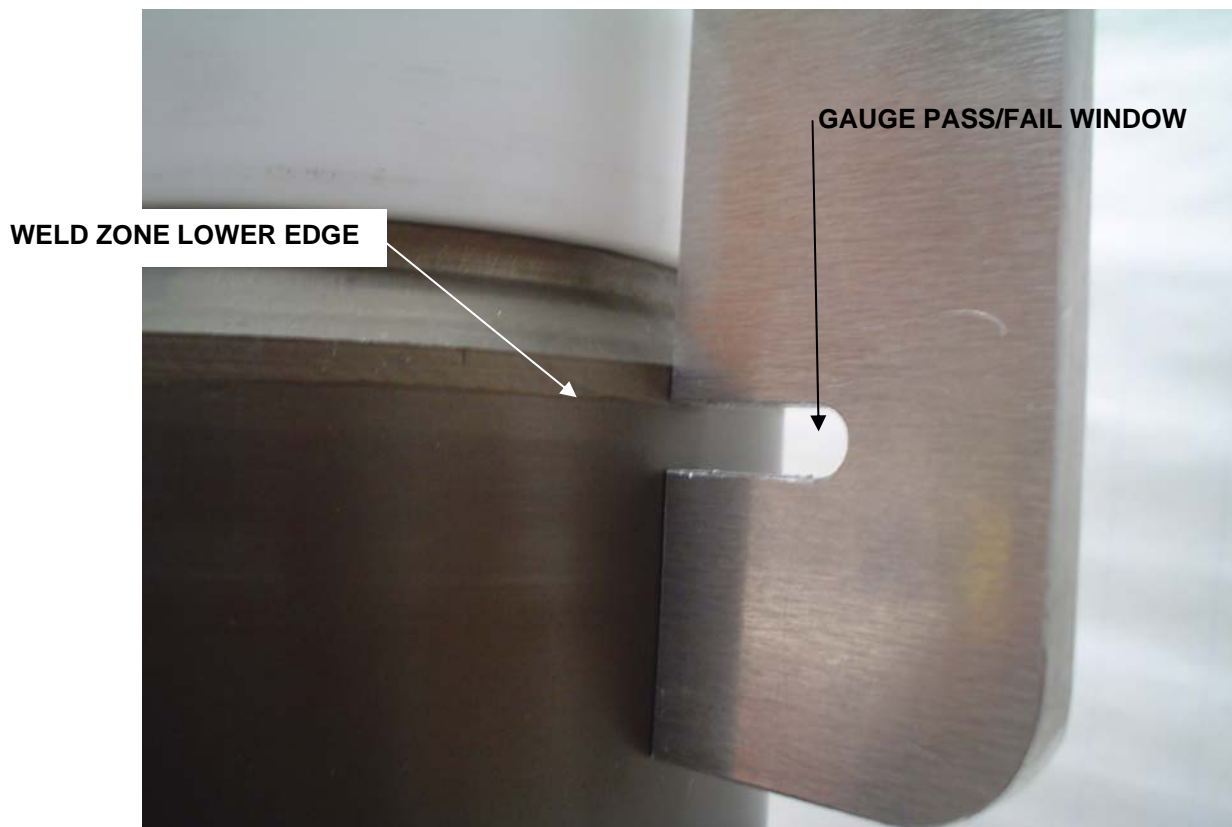
FIGURE 4 – WELD GAUGE PLACEMENT / USE

The inspection procedure requires use of the enclosed Weld Gauge Special Tool, supplied at no cost by STIDD Systems, Inc. with this Technical Bulletin. This gauge will allow the inspector to quickly and easily determine if the inner post weld is adequate.
